AIRBAG INVESTIGATION

CASE NO. 93-02

[REDACTED], LOUISIANA

**TECHNICAL REPORT**

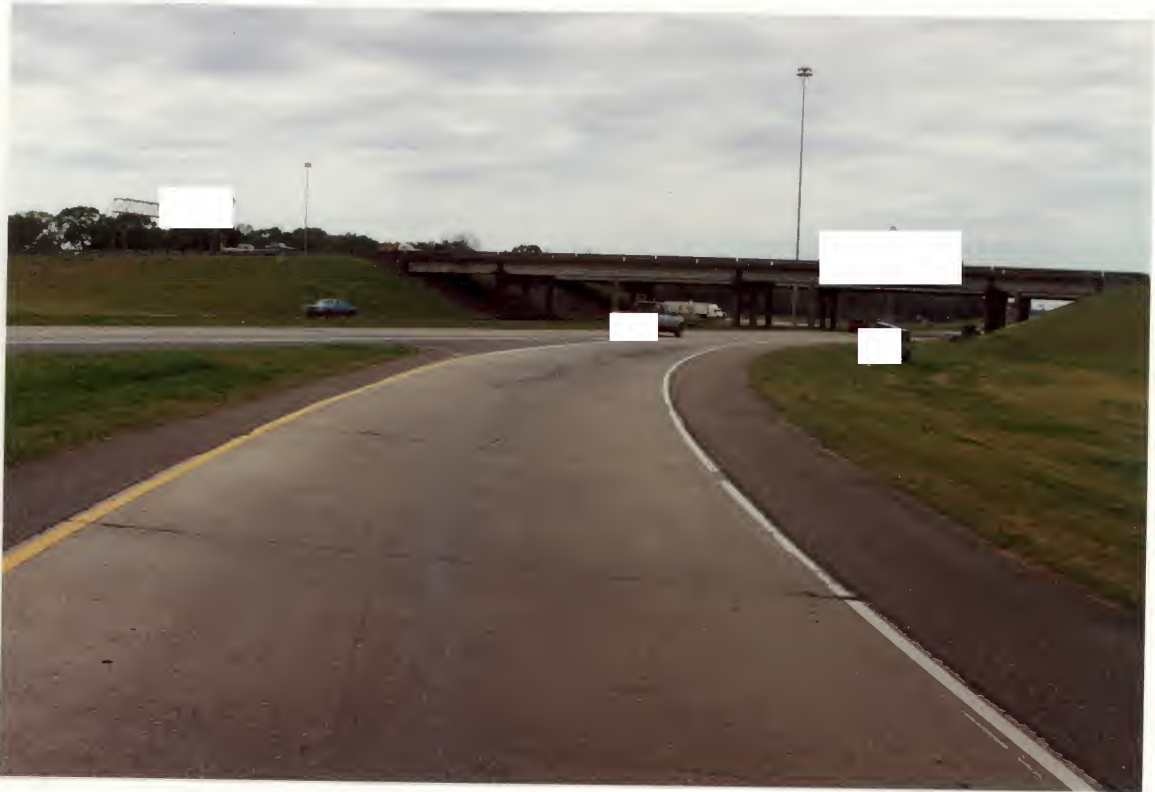
1. Photo of accident site looking north along the pre-impact travel path of the NX 1600 and Suburban.

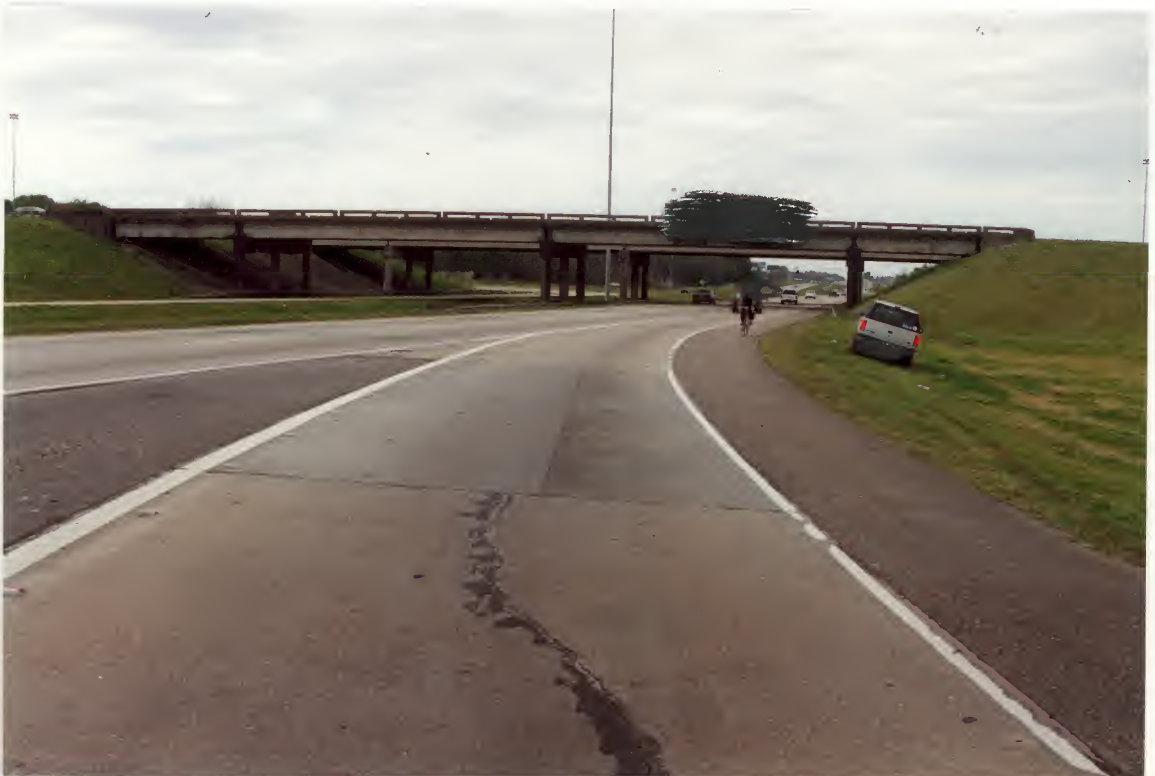
2. Additional view of pre-impact travel path of both vehicles.

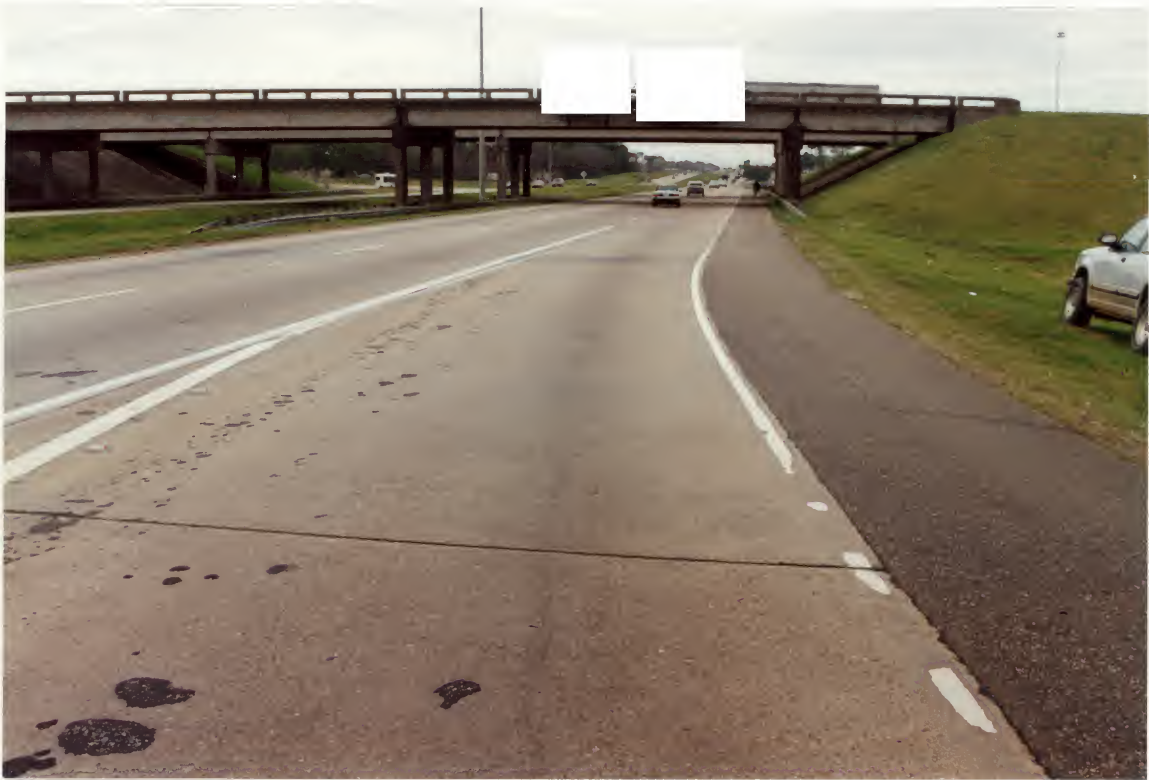
3. Area of impact and final rest of both vehicles.

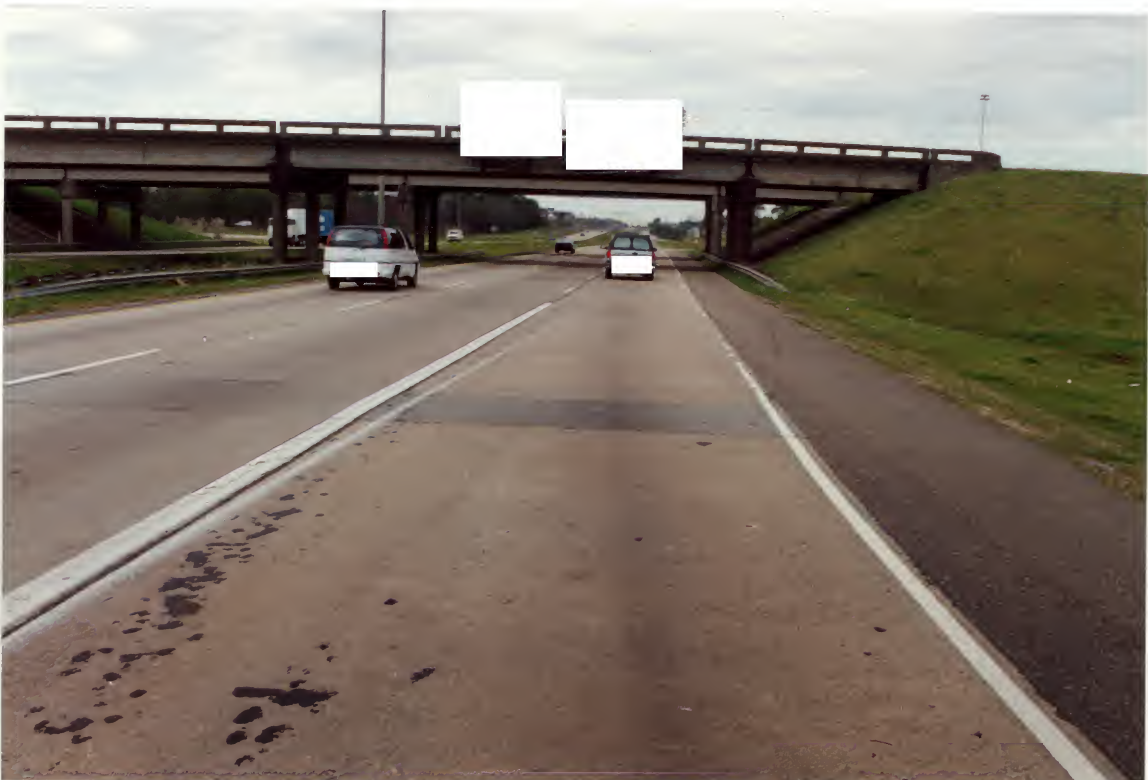
4. Additional view of impact and final rest area.

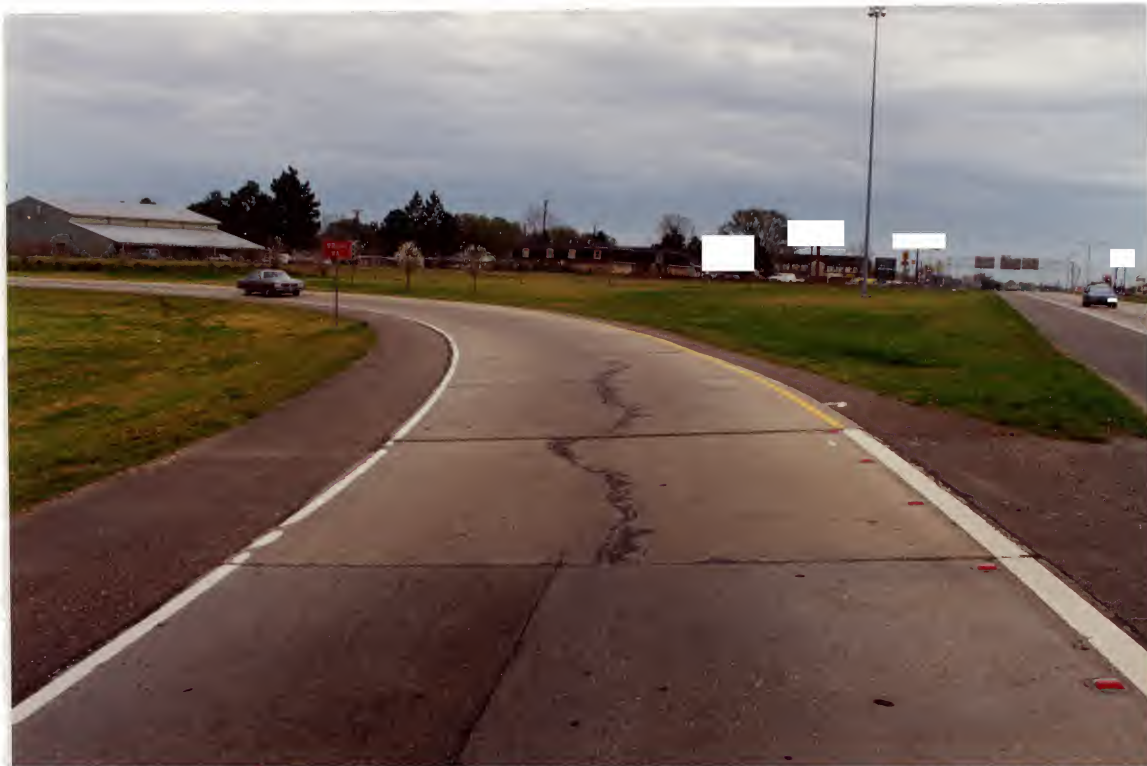
5. Opposite view of pre-impact travel path of both vehicles.

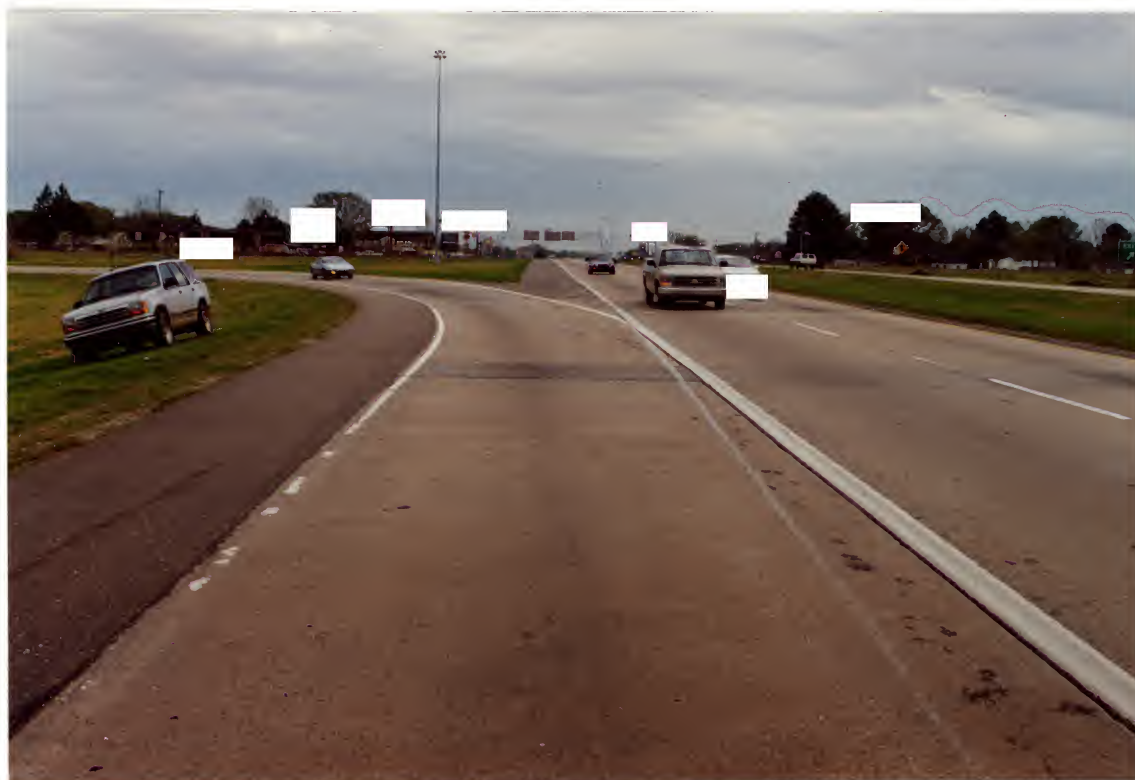
6. Opposite view from beyond impact and final rest.

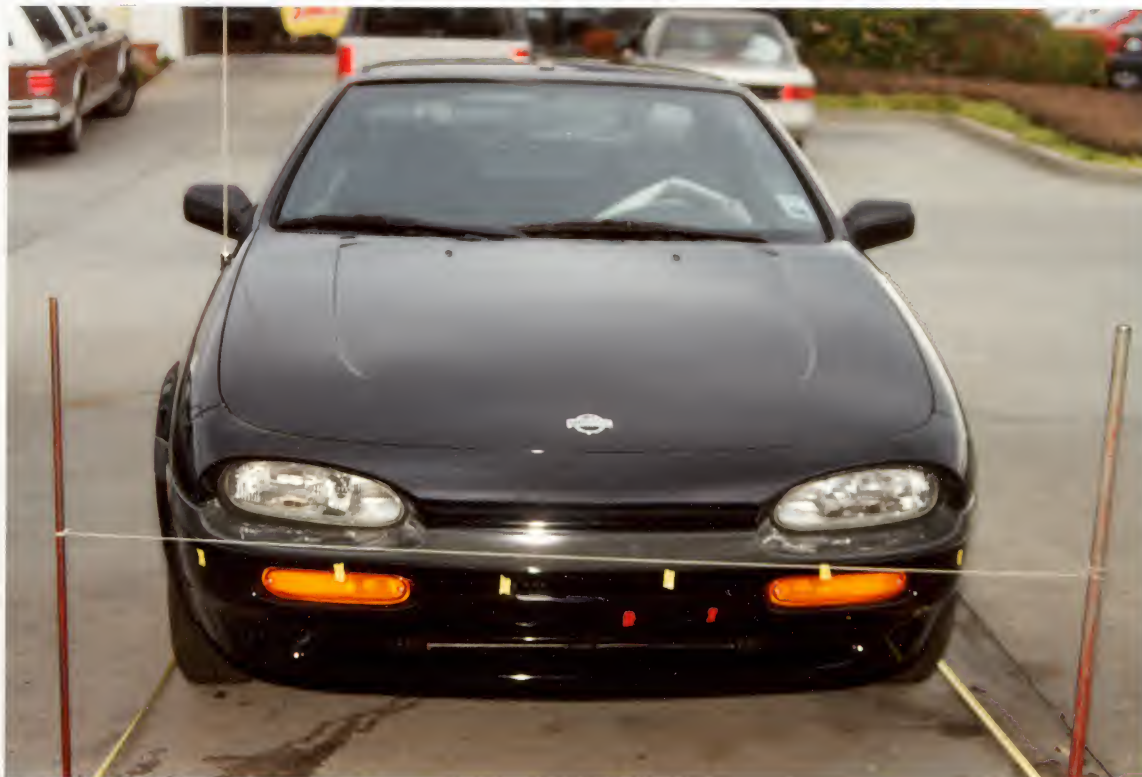
7. Frontal view of the 1992 Nissan NX1600.

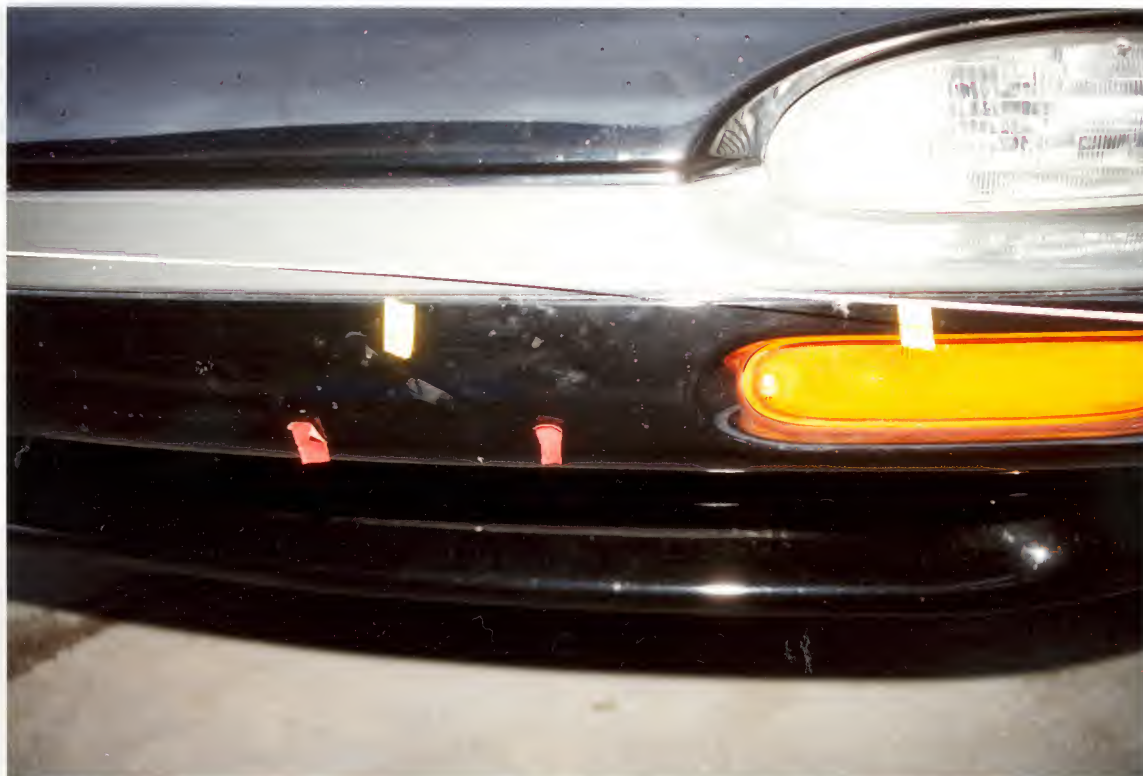
Damaged Components:	Damaged components included the front bumper cover and airbag.	The only damaged component reported was the rear bumper.
Interior Damage:	The front bumper cover sustained scratches and a rub from the impact, and the airbag deployed.	The Suburban was not inspected, but no damage to the interior was reported.

8. Closeup of possible scratches and transfer on the front bumper cover of the Nissan.

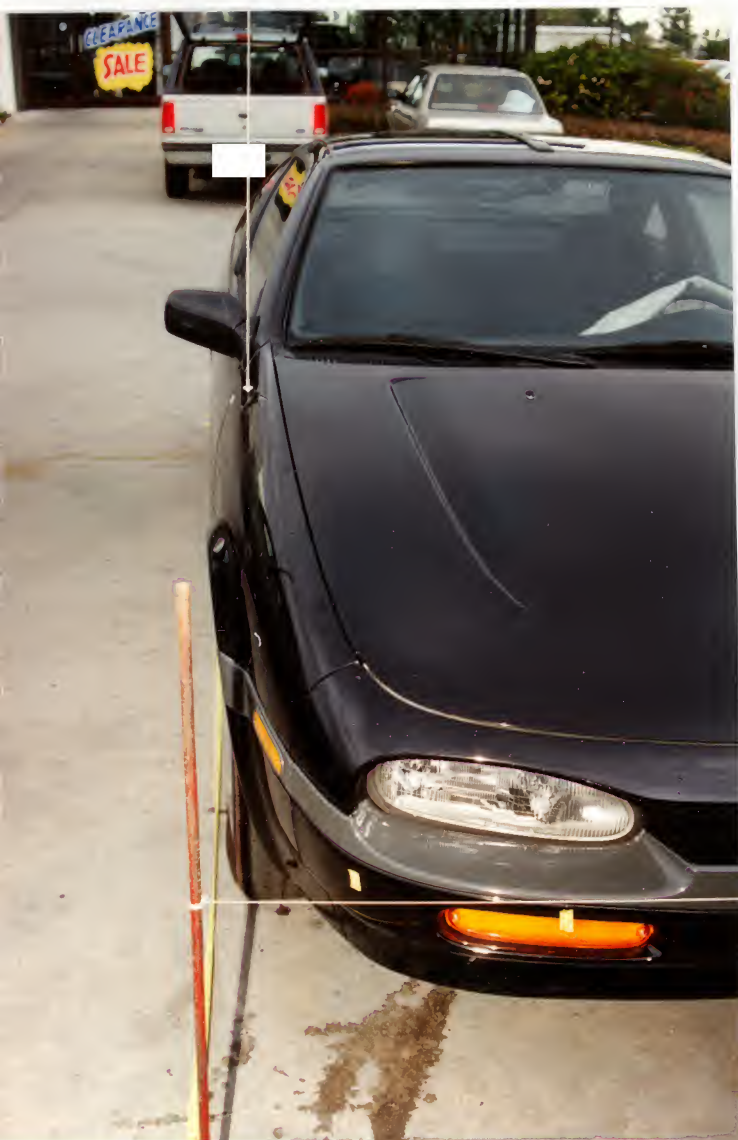
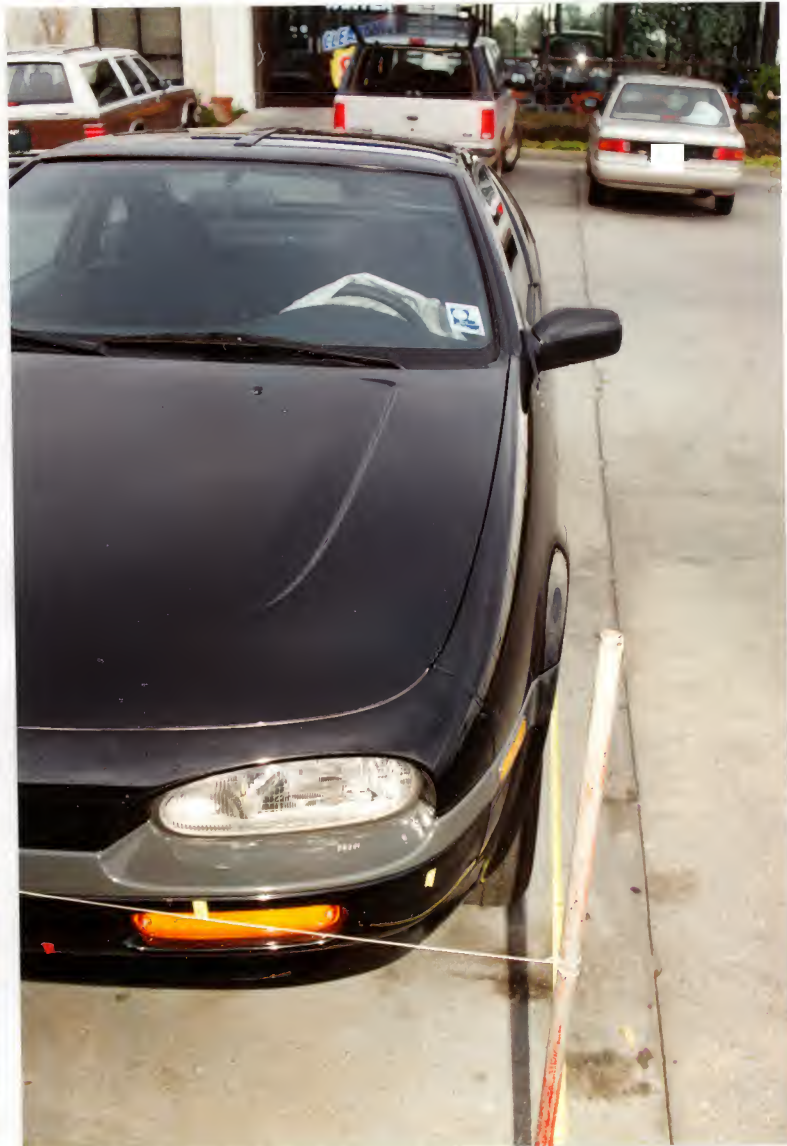
9-10. Additional frontal views of the Nissan.

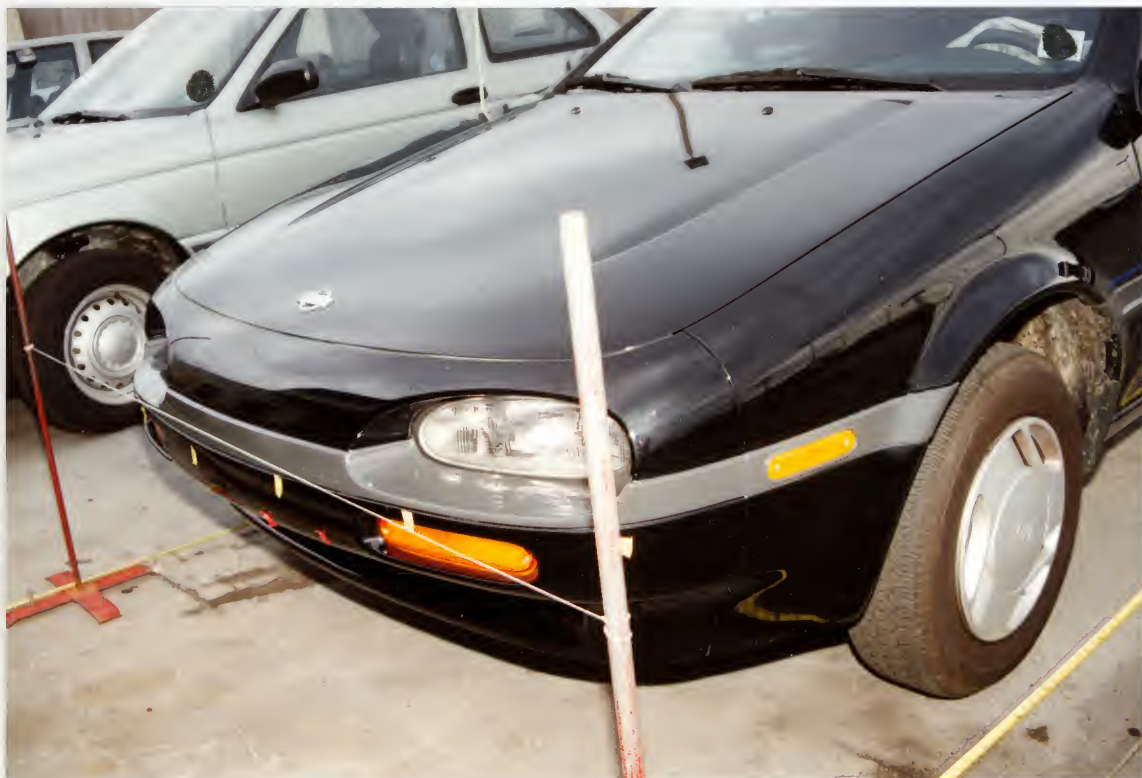
11. Front-left view of the Nissan.

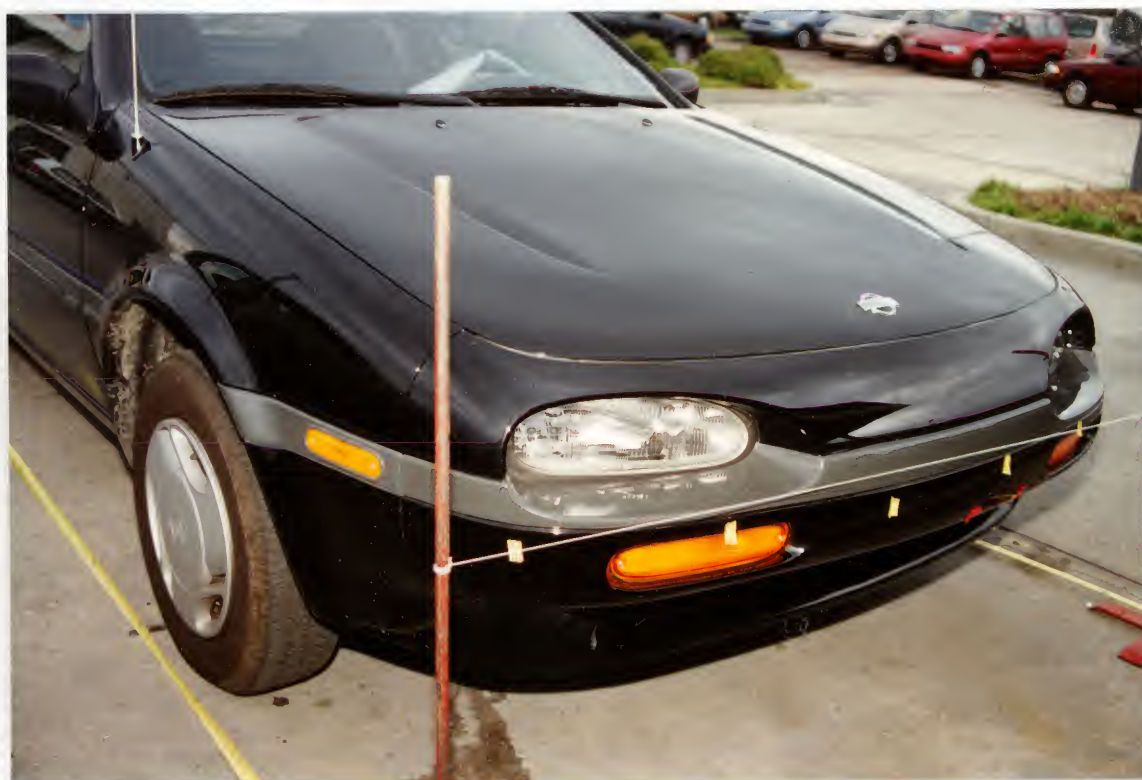
12. Front-right view of the Nissan.

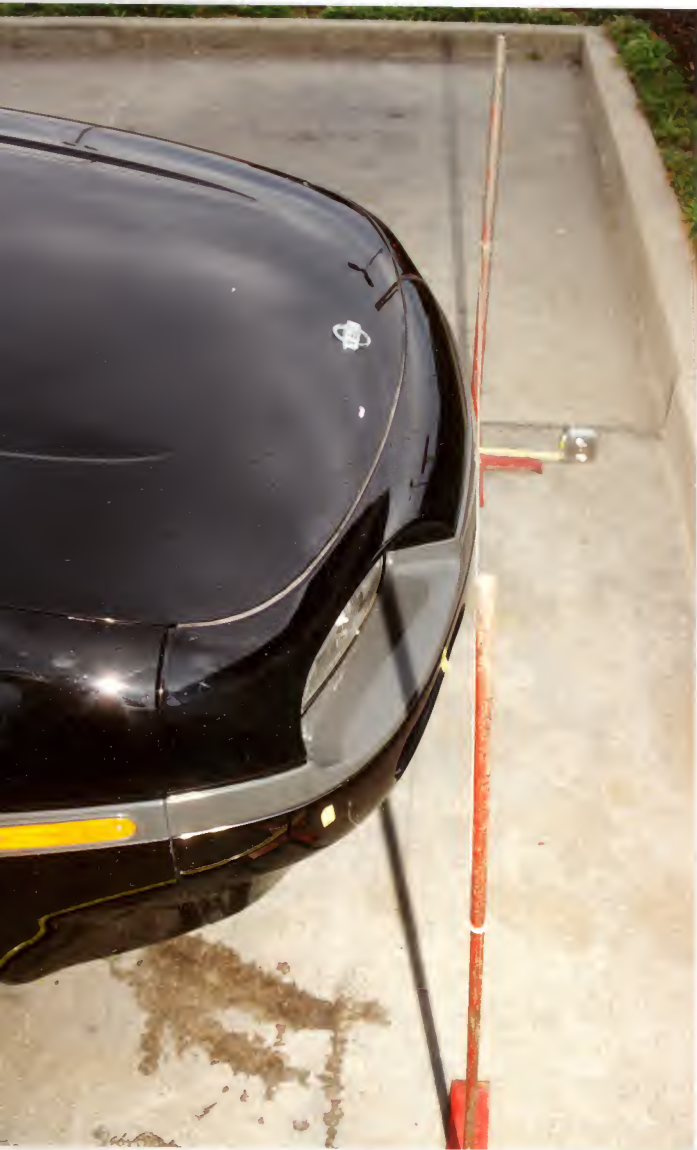
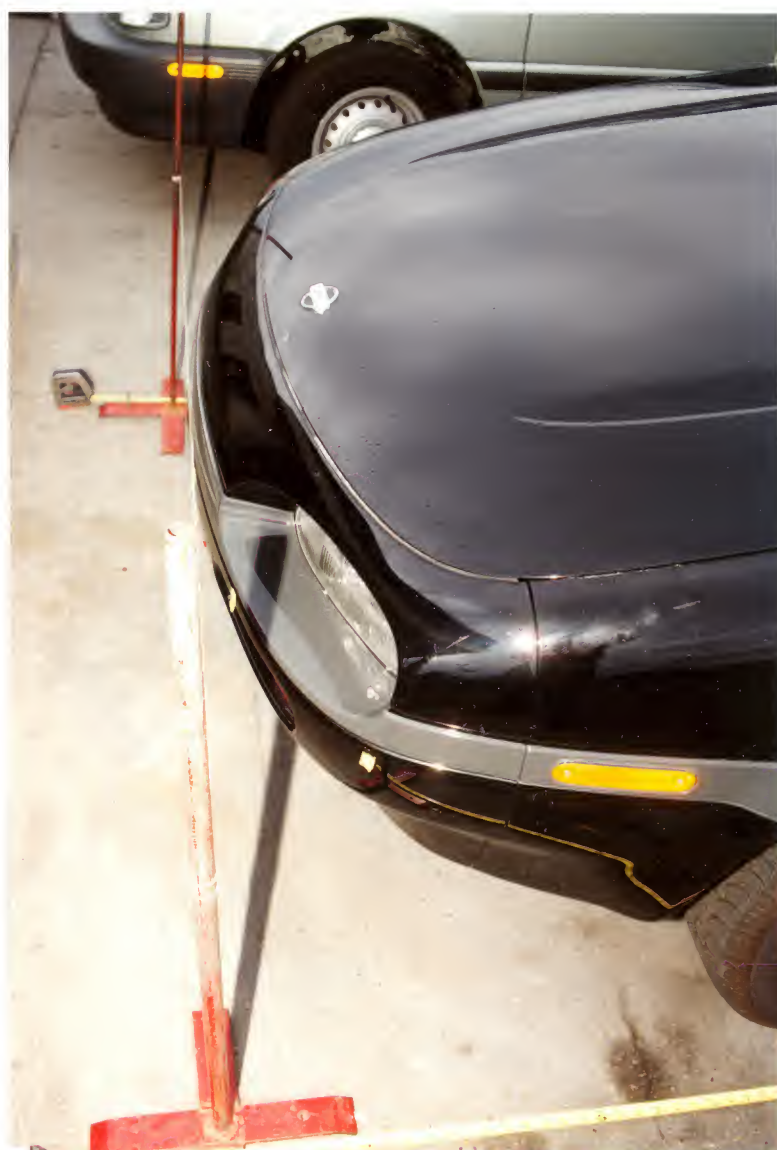
A CDC of 12 FYEW-1 was assigned to the damage to the airbag-equipped NX 1600. Maximum residual crush to the front of the NX 1600 was less than 1 inch to the front bumper. Only a small scratch and rub were noted to the plastic bumper cover. The Suburban was not inspected, but the only damage to it was apparently to the back bumper, which had to be replaced.

13-14. Views looking down the frontal stringline of the Nissan.

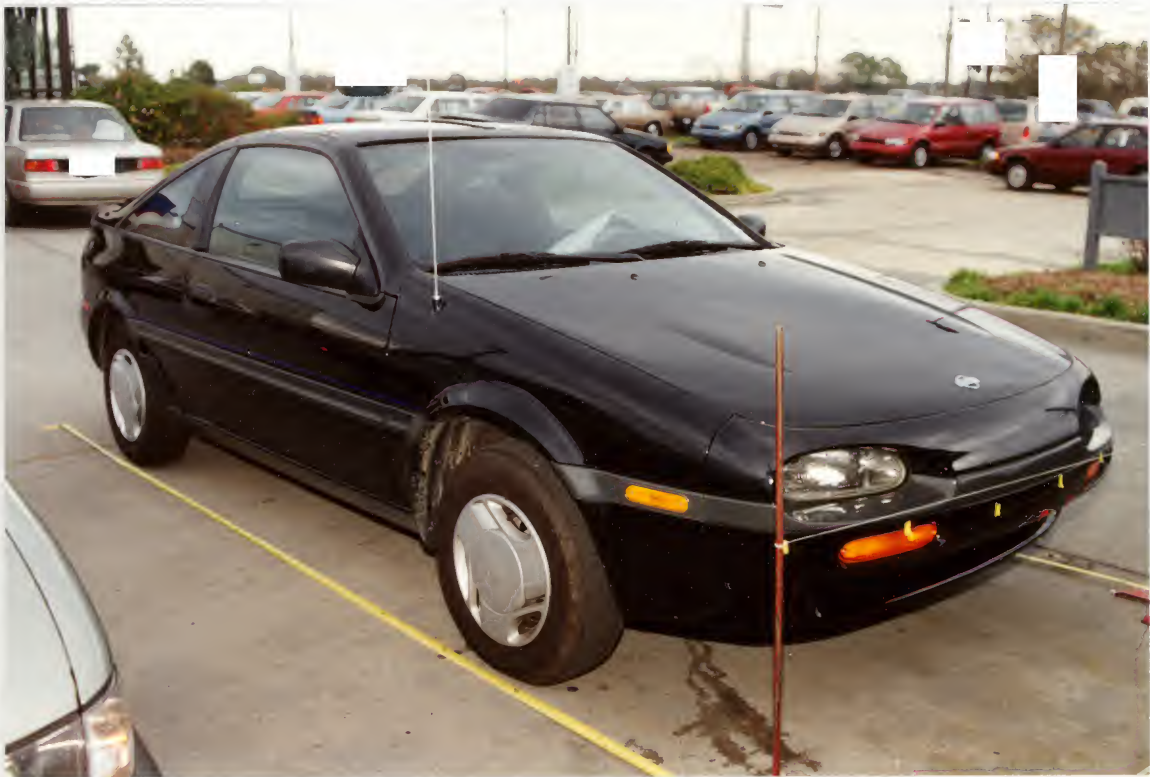
15. Front-right overall view of the Nissan.

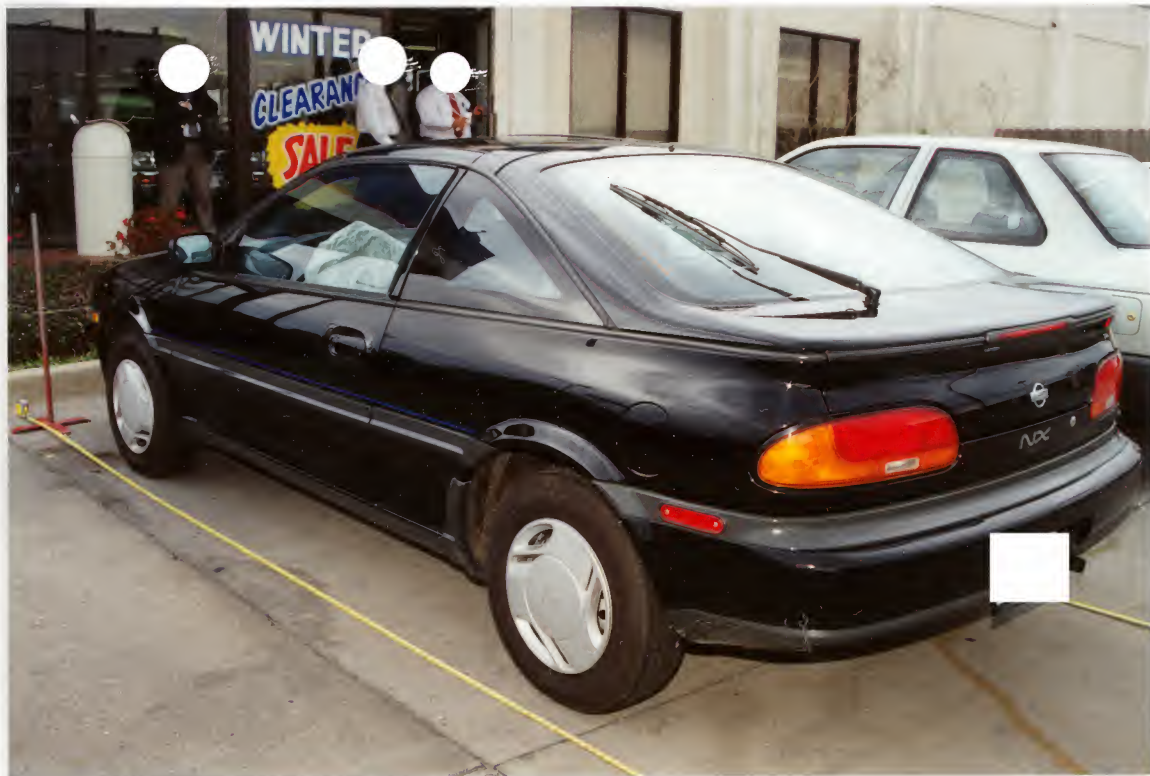
16. Back-left overall view of the Nissan.

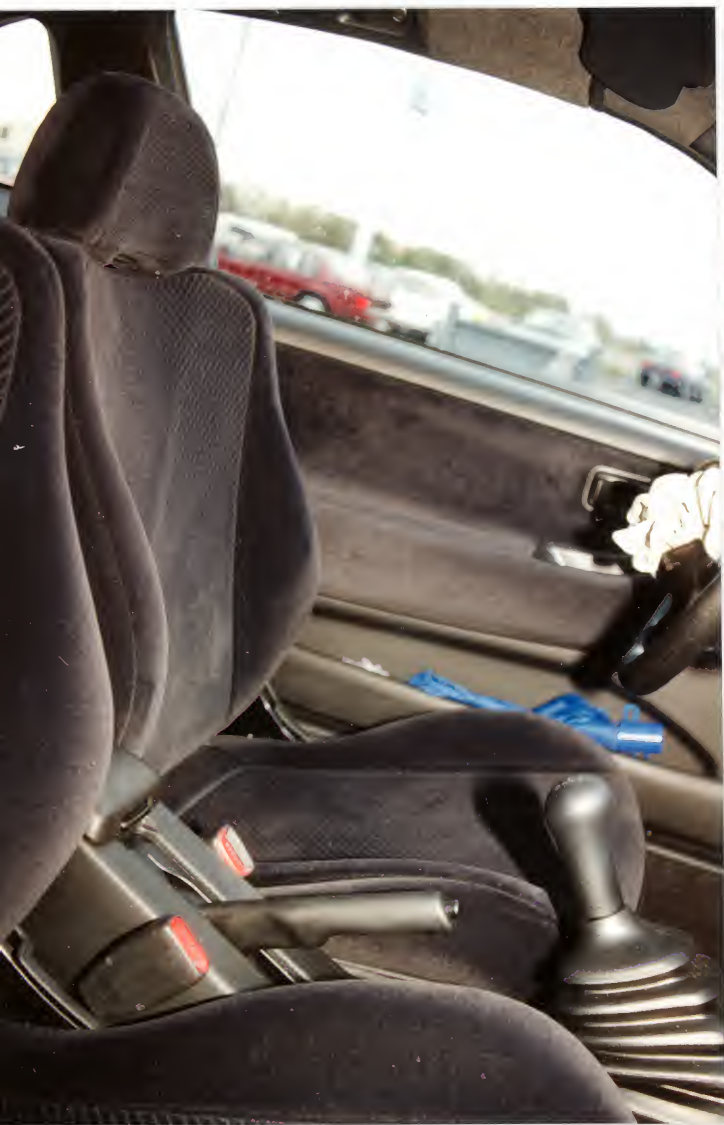
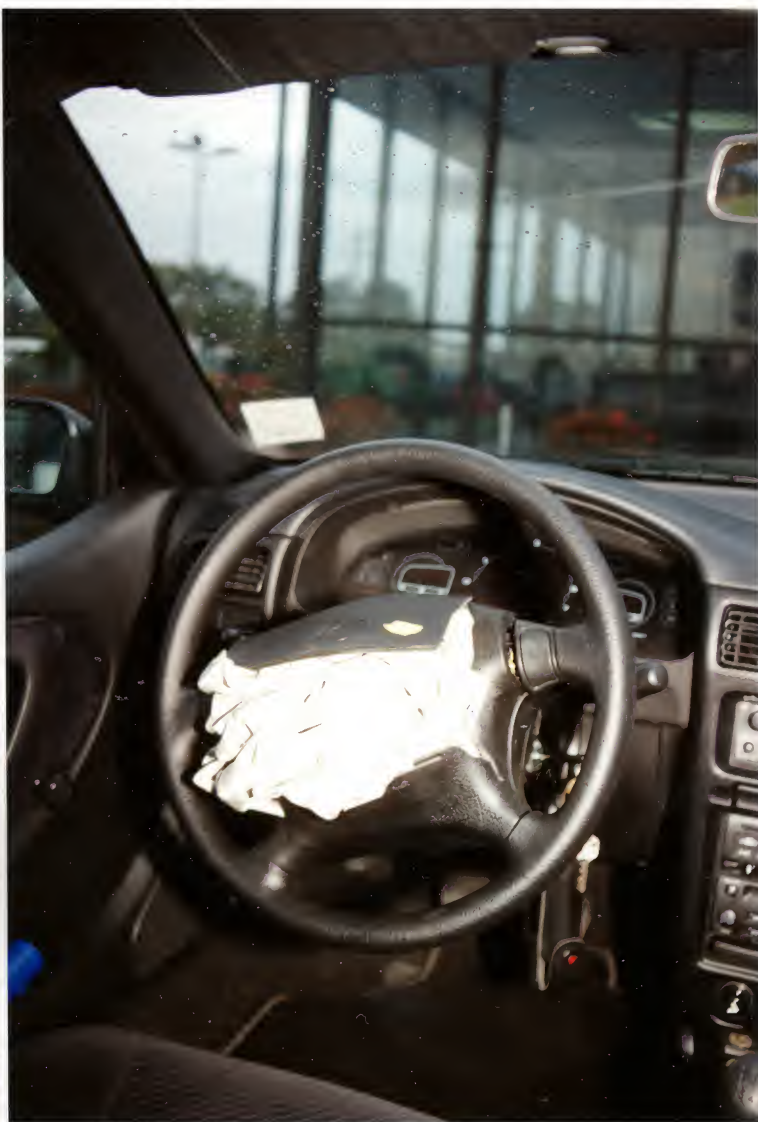
17-18. Views of the driver's seat, driver's door, steering assembly and left instrument panel.

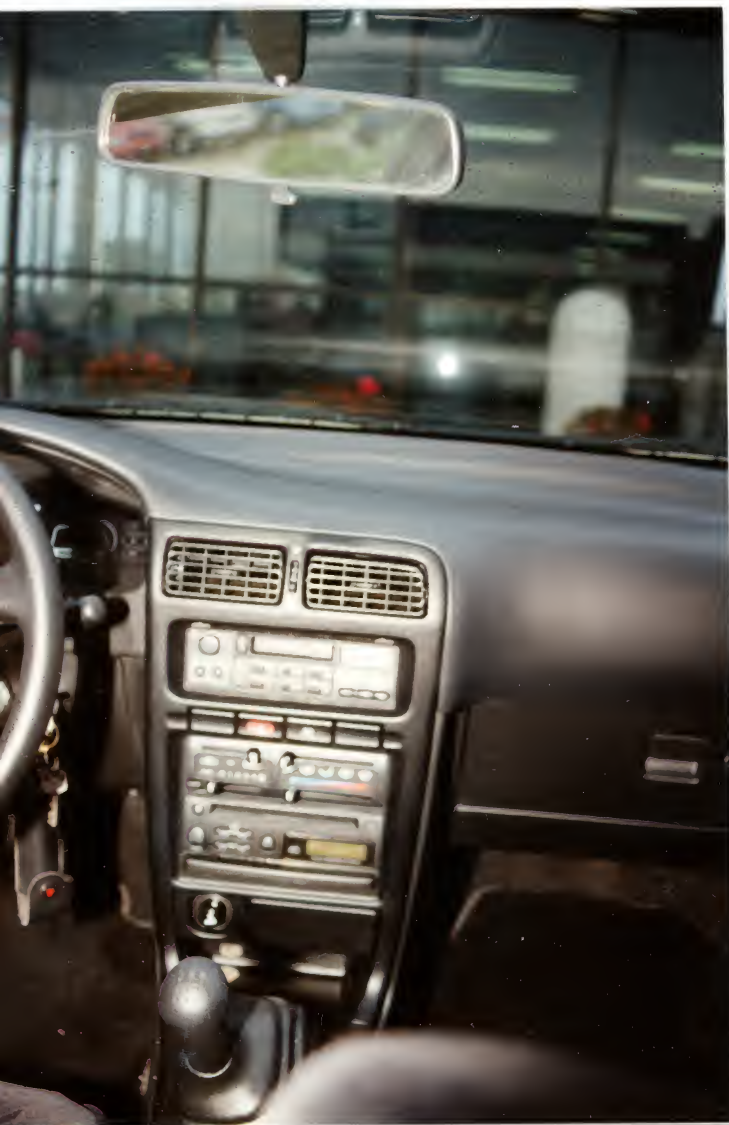
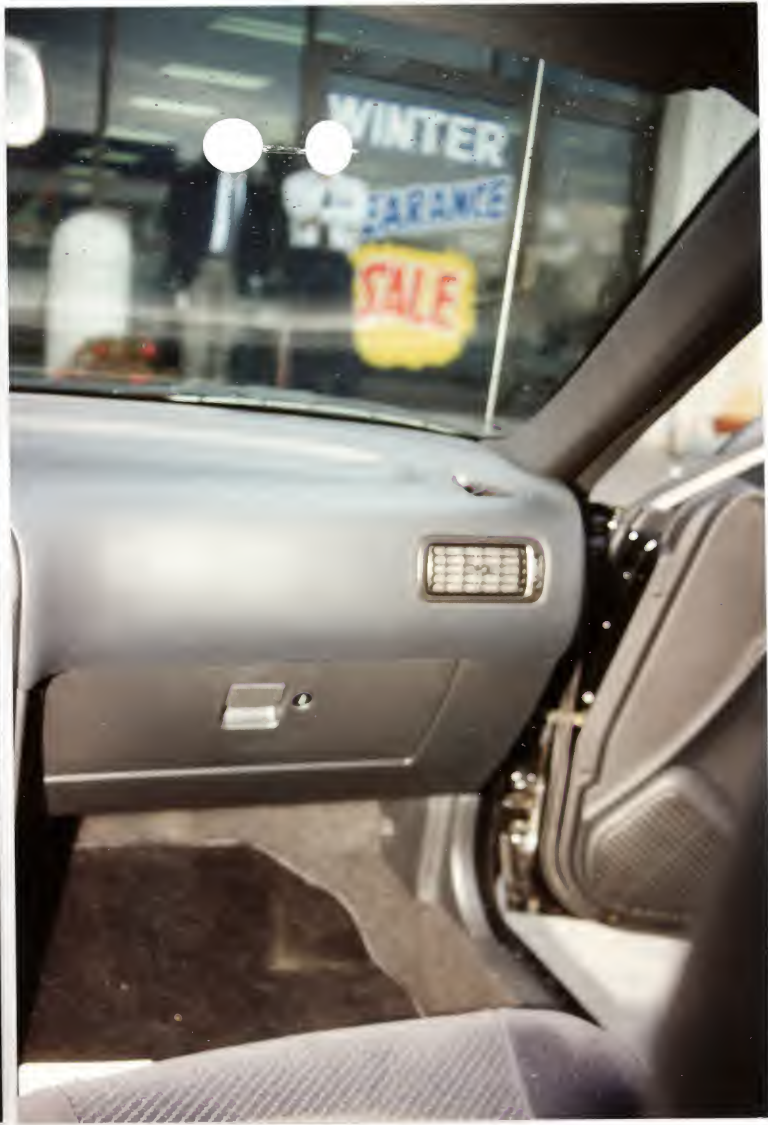
19-20. Views of center instrument panel and right instrument panel.

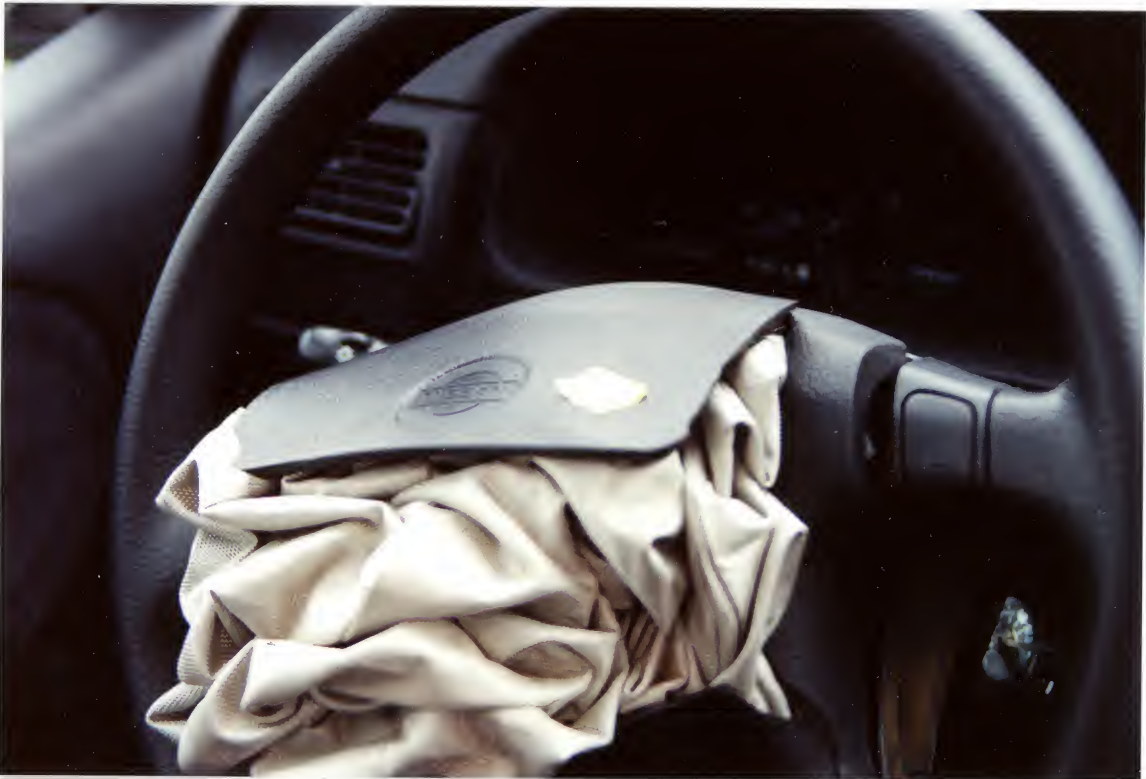
21. View of steering wheel and airbag cover flap.

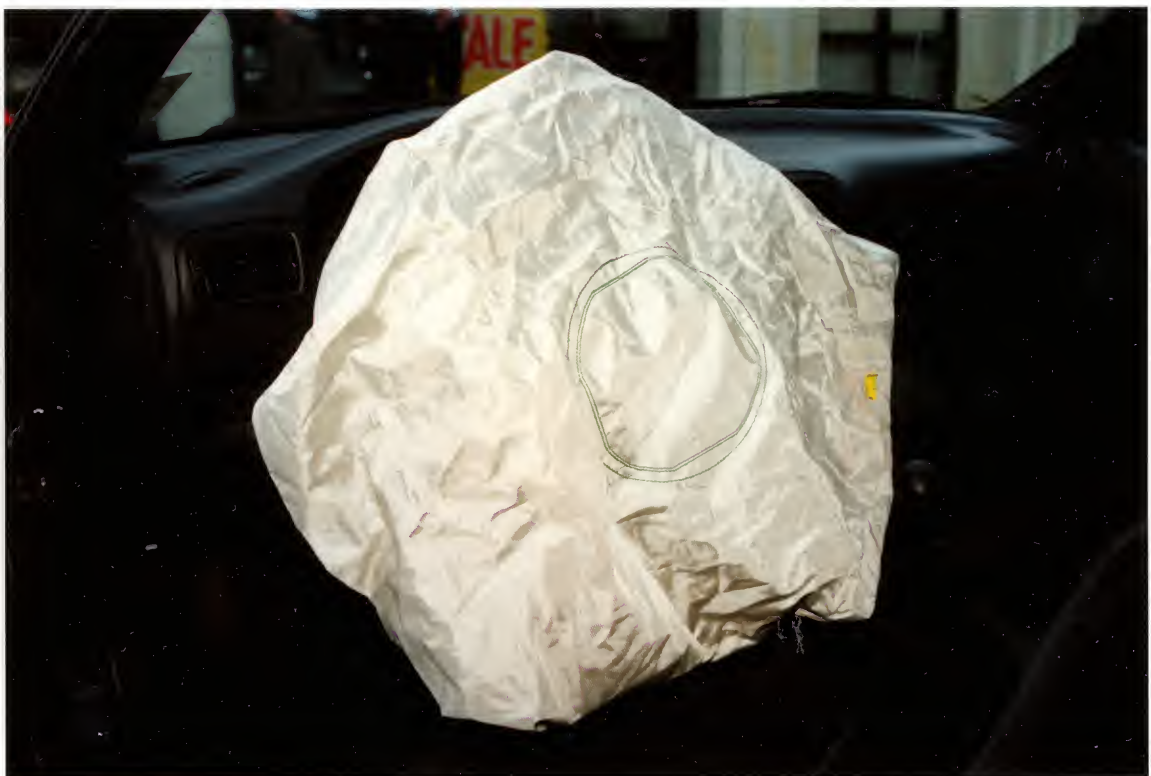
22. Overall view of deployed airbag.

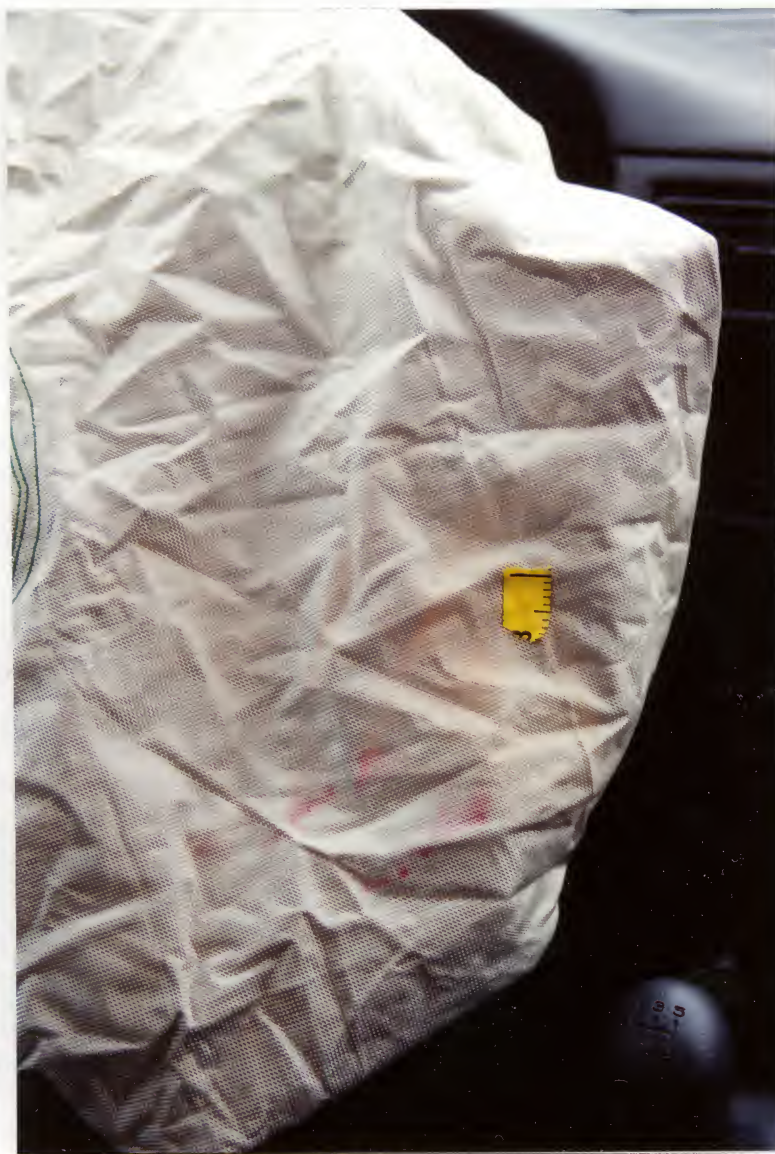
23. Closeup view of possible occupant contact to deployed airbag.
